June 28, 2019 File No. 262018.063

Subject: Department of Natural Resources Washington Geological Survey,

School Seismic Safety Assessment Project, Contract No. AE 410 -

Seismic Evaluation for Wilson Creek School District

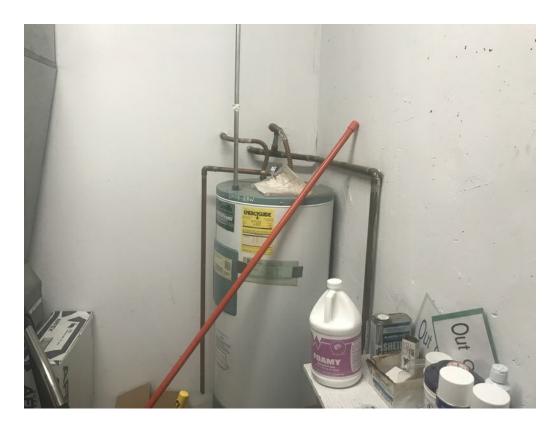
Figure 1-1. Water heater for the building.

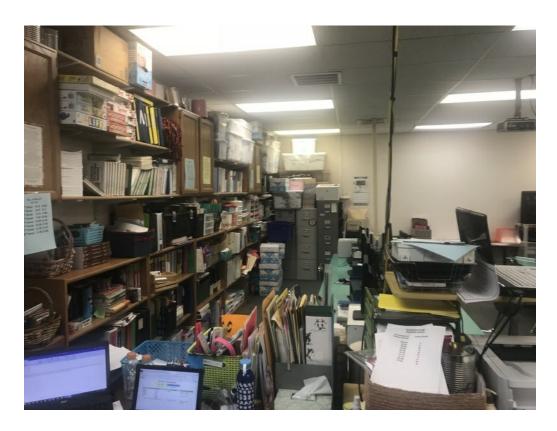
Figure 1-2. Shelves and storage cabinets in the computer lab.

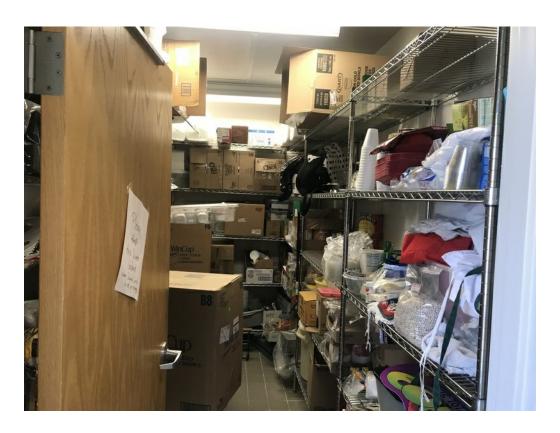
Figure 1-6. Storage room in kitchen area with tall shelves.

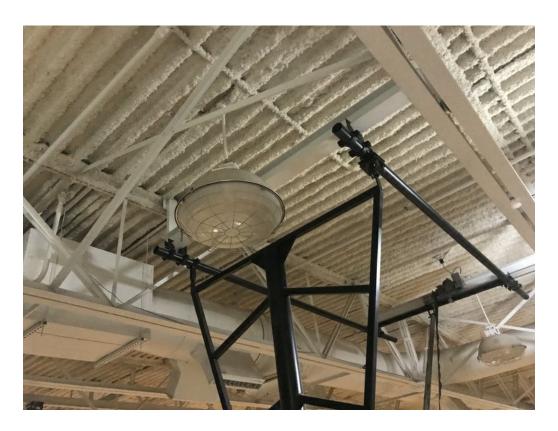
Figure 1-8. Connection of basketball hoops and pendant light in gymnasium.

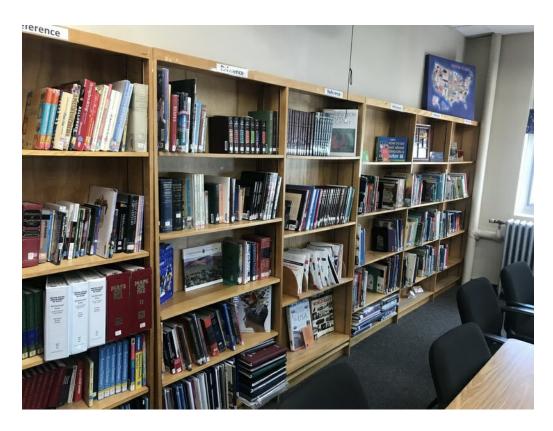
Figure 1-1. Library with tall shelving.

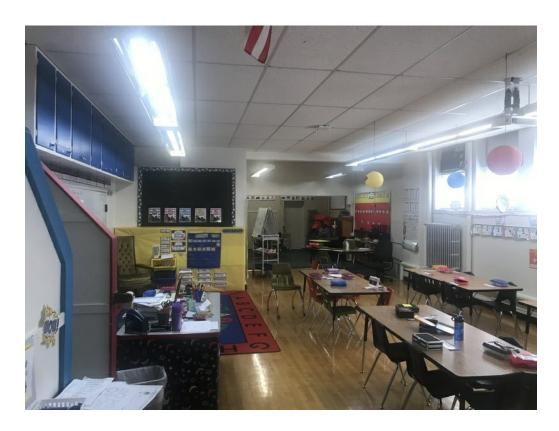
Figure 1-4. Typical classroom with fluorescent light fixtures and drop-in acoustical tiles.

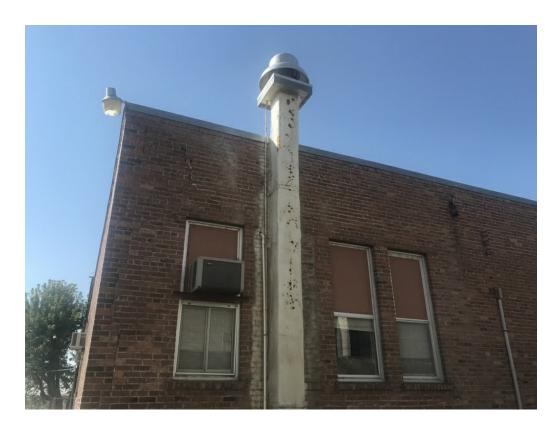
Figure 1-8. Chimney on north side of building (east end); appears to be of light-gauge steel construction.

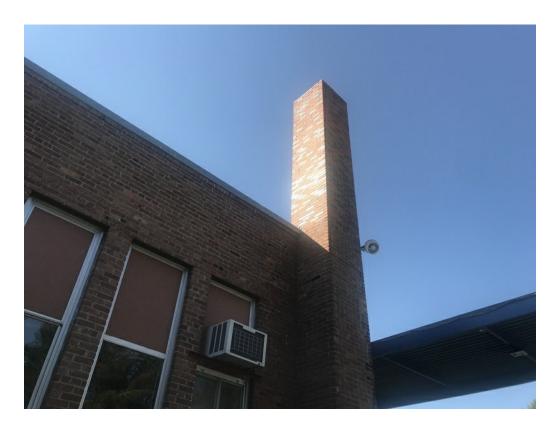
Figure 1-9. Tall URM chimney on northwest corner of building.

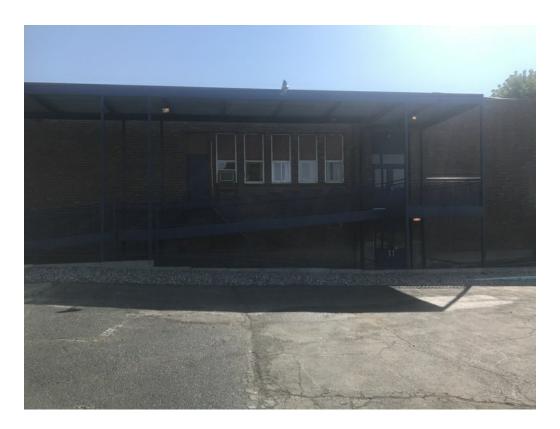
Figure 1-10. Steel-framed access ramp to second story.

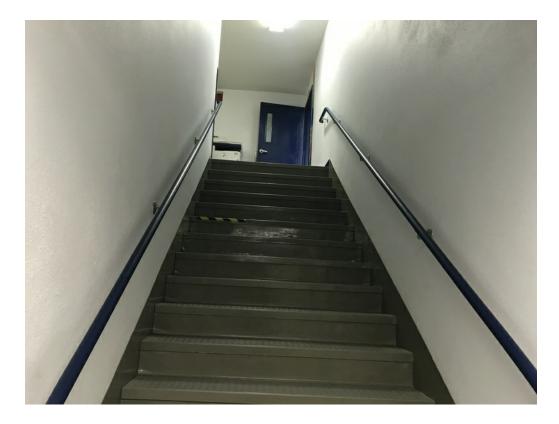
Figure 1-5. Stairs to second floor classrooms.

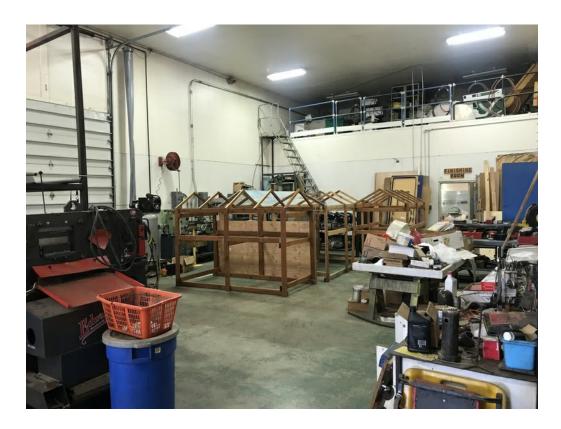
Figure 1-8. Welding shop with storage mezzanine visible.
